**Evolution of a Drainage Network:  
Remote Sensing Analysis of the North Fork Toutle River,  
Mount St. Helens, Washington**

WRRRI-88

November 1983

Final Technical Completion Report  
Grant No. 14-34-0001-1452

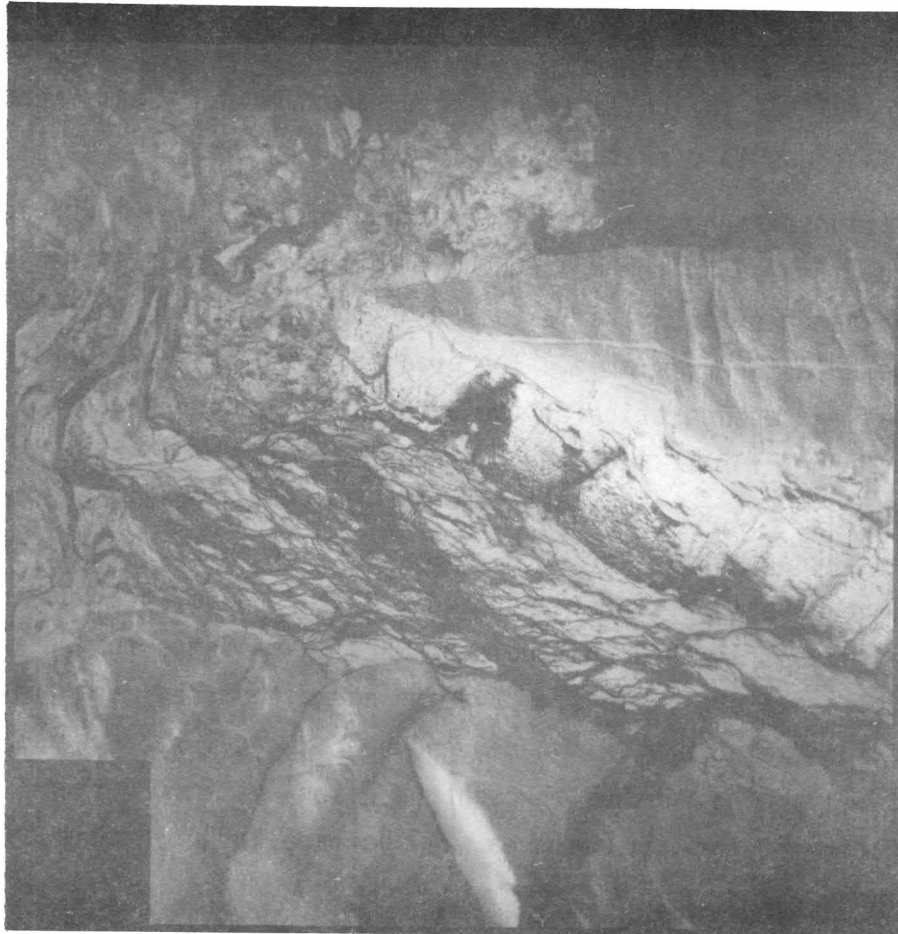
Figure 3. An example of stream braiding in the lower South Coldwater Creek watershed. This aggrading stream reach exhibits the characteristics typical of a braided stream network in which hundreds of channel links divide, subdivide, and reunite repeatedly. The snow cover serves to enhance the myriad of anastomosing channels. Coldwater Lake is the dark feature at the top of the photo. The photo date is 11 December 1981 (Oregon Army National Guard).

The eastern half of the December map has several interesting features of note. First, South Coldwater Creek provided a superb example of a braided channel network. The exact location of these channel flow lines was enhanced by the contrast provided by the snow cover (Fig. 3). Second, an imaginary line between Coldwater and Castle Lakes marks the approximate location of where the groundwater from the upper debris avalanche intersects the land surface. Here, numerous stream channels within a short drop in elevation and slope gradient show a transition from dry channel beds to streams with flowing water. Third, on no other map was the number of positively identifiable springs more prolific. Case in point are the many springs located on the north side of Johnston Ridge. Again, interpretation of these features was greatly aided by the presence of snow on the ground. Fourth, the spatial distribution and areal extent of the primary and secondary lakes located within the study area are clearly defined for the first time. Future analyses associated with the changes in lake levels (e.g., Spirit Lake) and the presence or absence of lakes and ponds makes this map particularly important when compared and contrasted with later interpretative maps in this series. Note the second major dominance area for lakes and ponds immed-

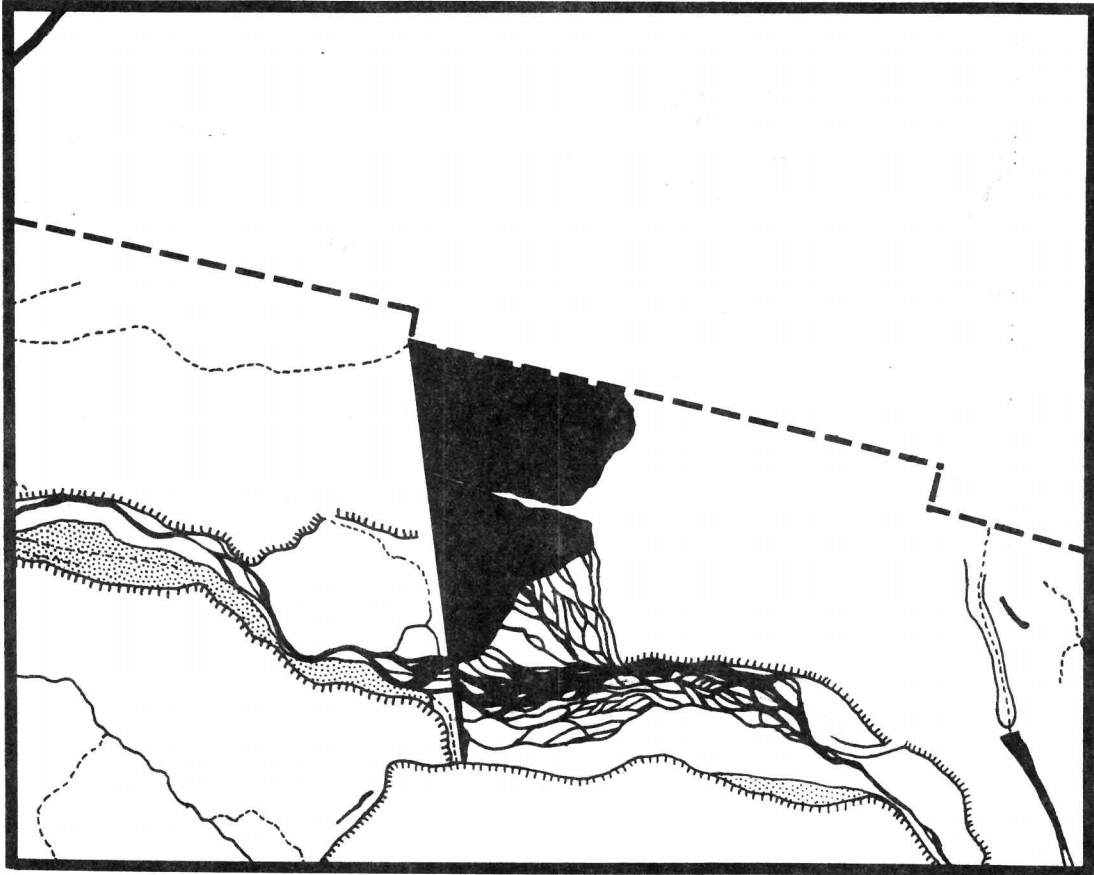
Figure 4. Physical appearance of the retention dam area on 13 October 1981.

During the summer and early fall of 1980, the U.S. Army Corps of Engineers constructed two adjacent sediment/debris retention structures across the North Fork Toutle River valley (designated DRS N-1). The dams are located between the distal end of the mudflow/debris avalanche deposits and Camp Baker. The purpose of these structures was to retain a large quantity of sediment and erosional debris close to the mountain in order to lessen the immediate effects and problems associated with excessive sediment deposition further down-river. By late December 1980 (less than three months after completion), the southern storage area had been filled with approximately  $8 \times 10^6 \text{ m}^3$  of sediment and debris (Lehre, Collins, and Dunne, 1981, p. 222). During peak runoff conditions, sediment was being transported directly through the south spillway. The following sequence of maps chronicles the rapid changes that transpired in this particular reach of the river during the 1981-82 water year, including: channel characteristics associated with aggradational processes; the February 1982 failure of the north dam spillway; and accelerated erosion resulting from multiple breaches in the dam structures. Due to limited air photo coverage, the 13 October 1981 map (Fig. 4) includes an interpretation of only the southern half of the retention dam site. Sediment deposits have partially filled the designated storage area. Suspended sediment and bedload is cascading unimpeded over the spillway.

A braided river pattern with anastomosing channels characterize the surface of the storage area. Off-shoots from the main stem of the river are in the process of filling in the northwest quadrant of

the storage area and thereby reducing the remaining surface water storage capacity. An alluvial fan-shaped feature is present indicating that there is a change in the channel slope which encourages deposition. The location of the access road and levee situated between the north and south storage areas is also indicated on the map.

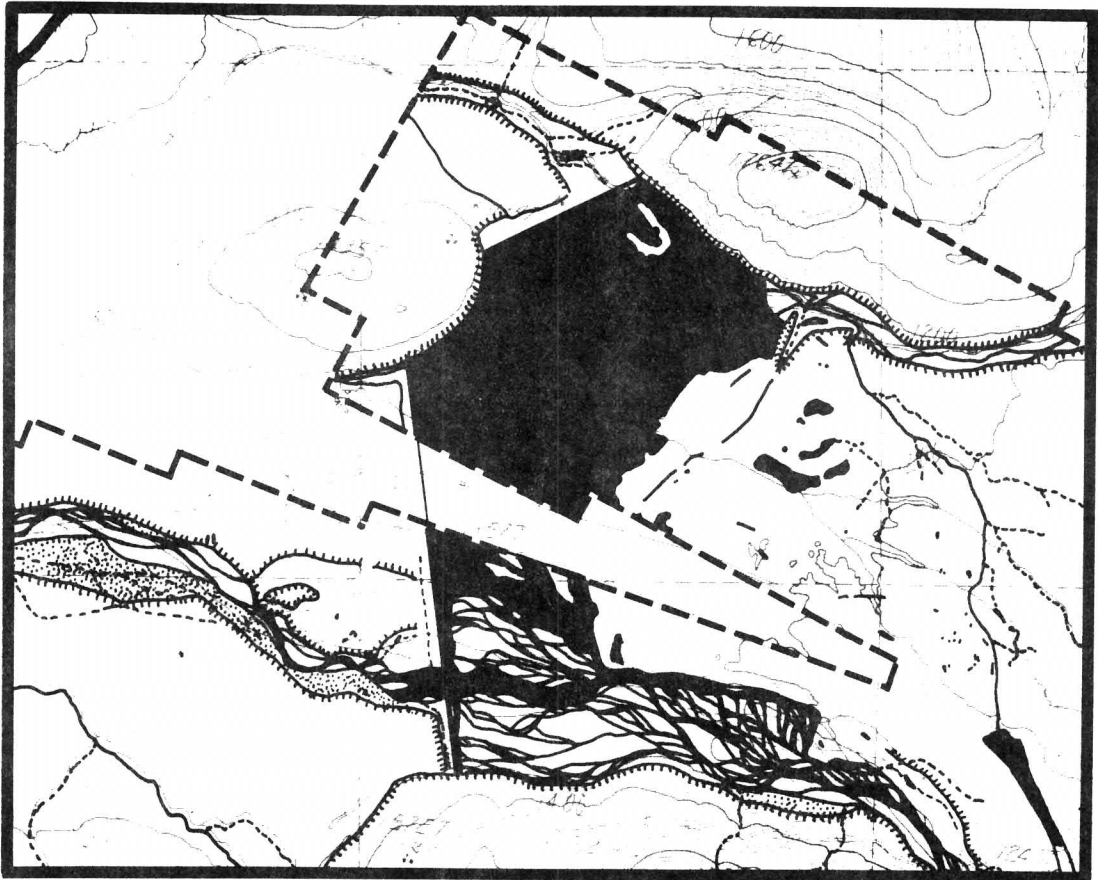
Figure 5. Physical appearance of the retention dam area on 24 November 1981.

The 24 November 1981 map (Fig. 5) suggests an increase in the volume of river discharge since the preceding map date. The increased discharge is in direct response to runoff from the first rainfall producing storms of the fall season. The braided pattern of the river has extended headward approximately 275 m (900 ft). The direction of sediment input continues to be toward the northwest quadrant. Each new runoff pulse contributes to the buildup of sediment and the corresponding loss of surface water storage. Surface water storage behind the south dam structure has nearly been eliminated. Except for a small gap between flightlines, the location of both dam structures and relationship of their respective storage areas are shown for the first time. The 11 and 16 December 1981 map (Fig. 6) shows the large reservoir situated behind the northern dam, while the southern dam where the main river flow is occurring, has been completely filled in with sediment. A small off-shoot branch from the main stem of the river continues to flow in a northerly direction towards the northern reservoir. The road/levee separating the two catchment areas has recently been breached. Small quantities of discharge and sediment are entering the north reservoir at the breached point. The surface height of the north reservoir appears to have increased on the order of approximately .5 to 1 m (1.6 to 3.3 ft). Note the change in the spatial distribution of terraces immediately west of the south spillway. Portions of the stored sediment have been eroded away by the meandering river channel and transported further down-river.

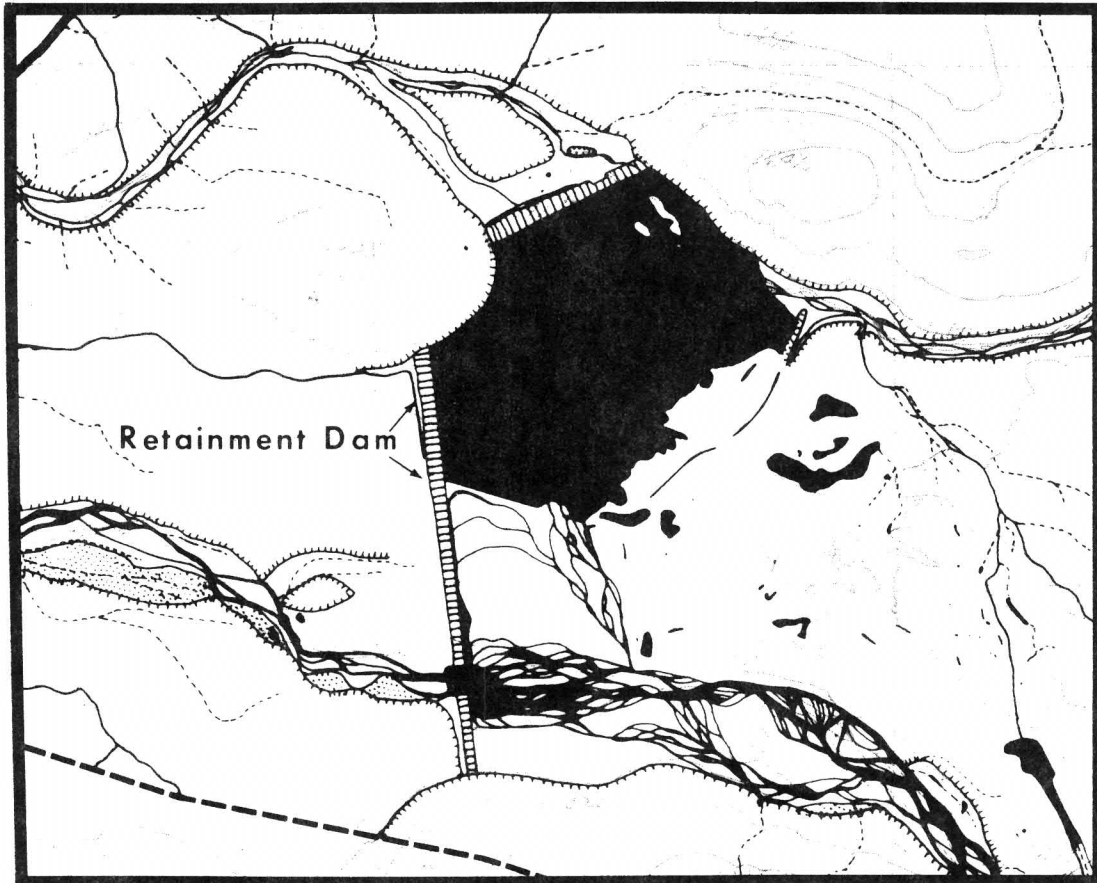
Figure 6. Physical appearance of the retention dam area on 11 and 16 December 1981.

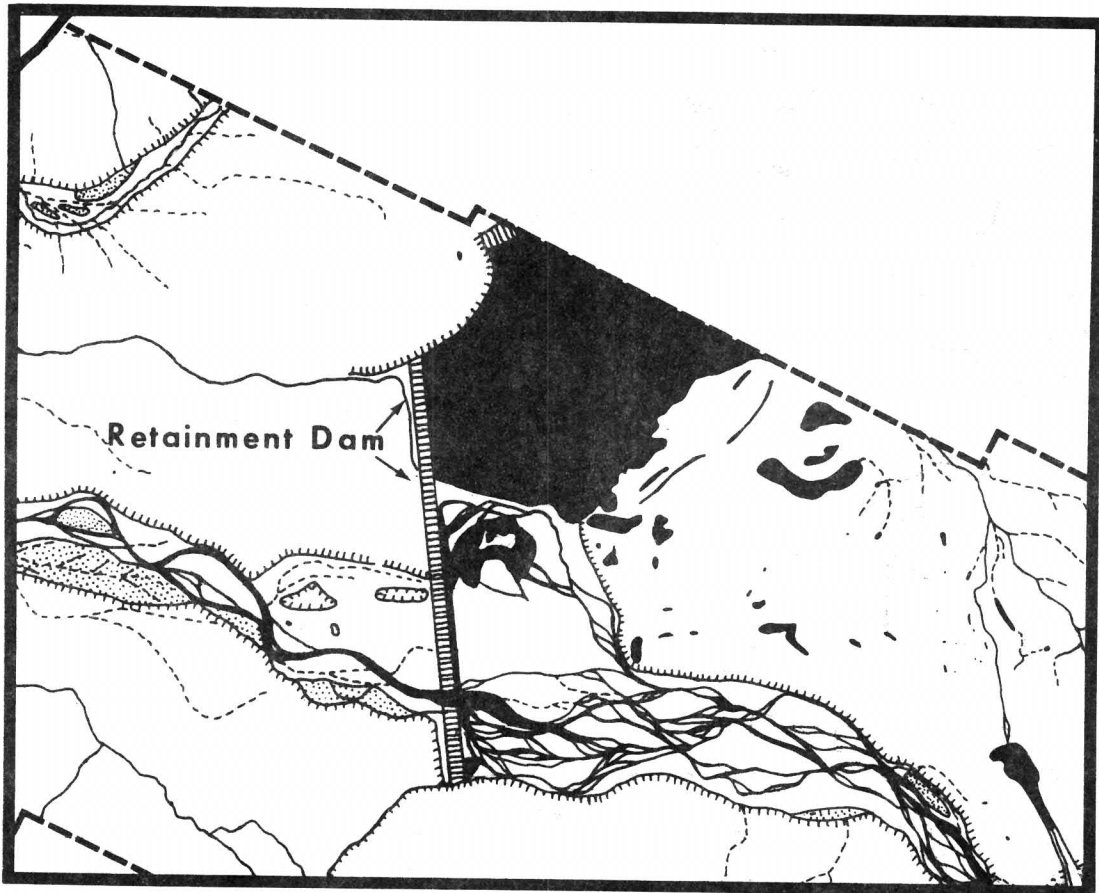
Figure 7. Physical appearance of the retention dam area on 06 February 1982.

The 06 February 1982 map (Fig. 7) indicates that the width of the floodplain behind the south structure has increased to the north

by approximately 45 m (150 ft). This growth appears to be in response to lateral erosion resulting from the growth and extension of in-channel sediment storage. The area of channel braiding extends across the entire breadth of the floodplain. The break between the two storage areas has been plugged. The small north flowing branch of the river is now looping back along the south dam structure. An area of temporary shallow, water storage south of the access road/levee is also indicated on this map.

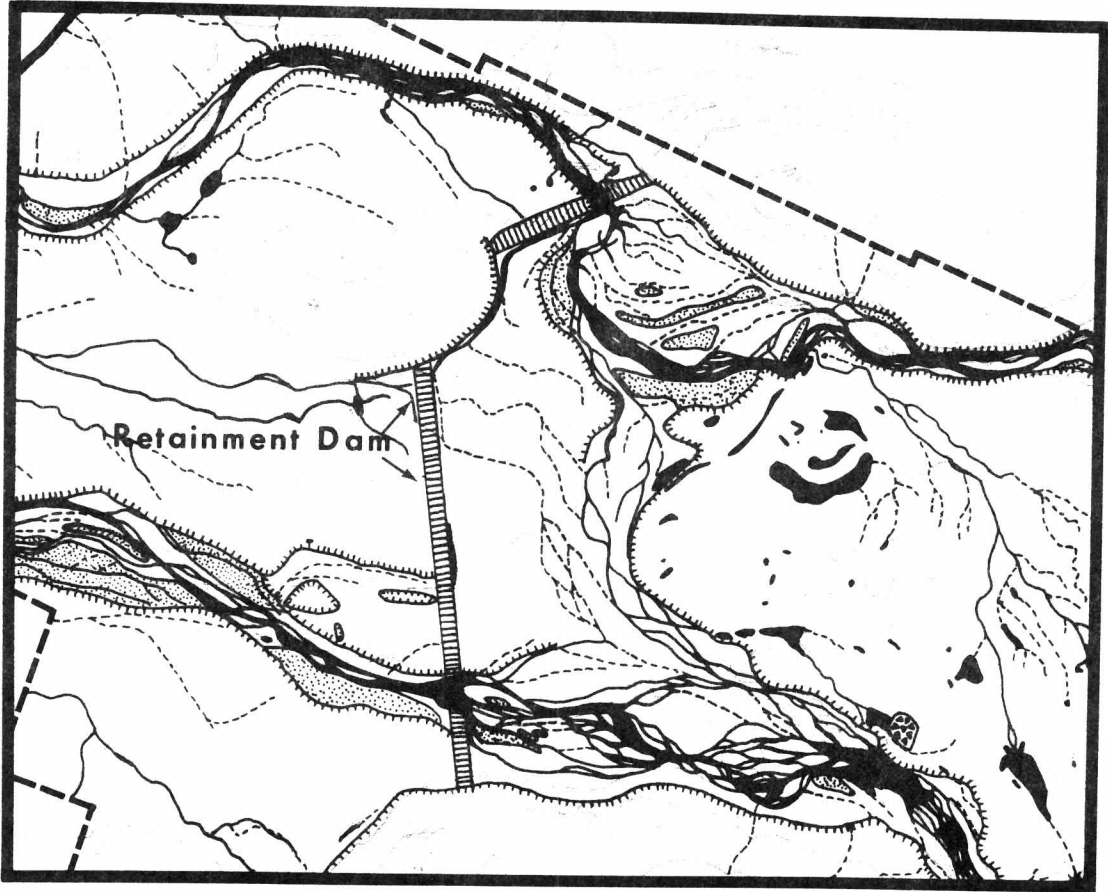
Figure 8. Physical appearance of the retention dam area on 05 March 1982.

The most significant changes to the hydro-morphologic character of this particular reach of the river valley are illustrated on the 05 March 1982 map (Fig. 8). The substantially altered configuration of features are the direct result of: (1) peak discharge rates following a sustained period of precipitation in February 1982; and (2) major upriver channel changes. The north dam spillway failed on 20 February 1982 when a flood surge entered the north reservoir storage area from Bear and Hoffstadt Creeks. The flood surge originated west of the Elk Rock area (SW1/4, Sec. 1, T9N, R3E) when the peak runoff flow (perhaps as much as 30 to 50 percent of the total river discharge) bifurcated northward into a developing gully system that was a tributary to Bear Creek (Fig. 9, bottom). The possibility of such a sequence of events occurring was indicated as early as mid-December 1981 when a small stream flow was shown originating at the flood-stage bifurcation point (Fig. 9, top). The collapse of the north spillway resulted in the rapid drainage of the stored water and the initiation of a multiple series of interrelated erosional processes. These associated processes probably included: liquefaction movement of super-saturated fine to coarse grained sediments; the occurrence of slump/earthflows resulting from the removal of toe-support as the ensuing erosional channel developed; and the clearly identifiable development of headward migrating gully systems. As the new channel continued to cut down through the spillway, distinctively large terraces were produced. Within the main channel, a knickpoint of considerable height is observed

from the available imagery to be migrating headward through the former deposits of sediment and debris. Discharge from the main stem of the river continues to flow towards and then through the north spillway in response to the integration of the two sediment storage areas.

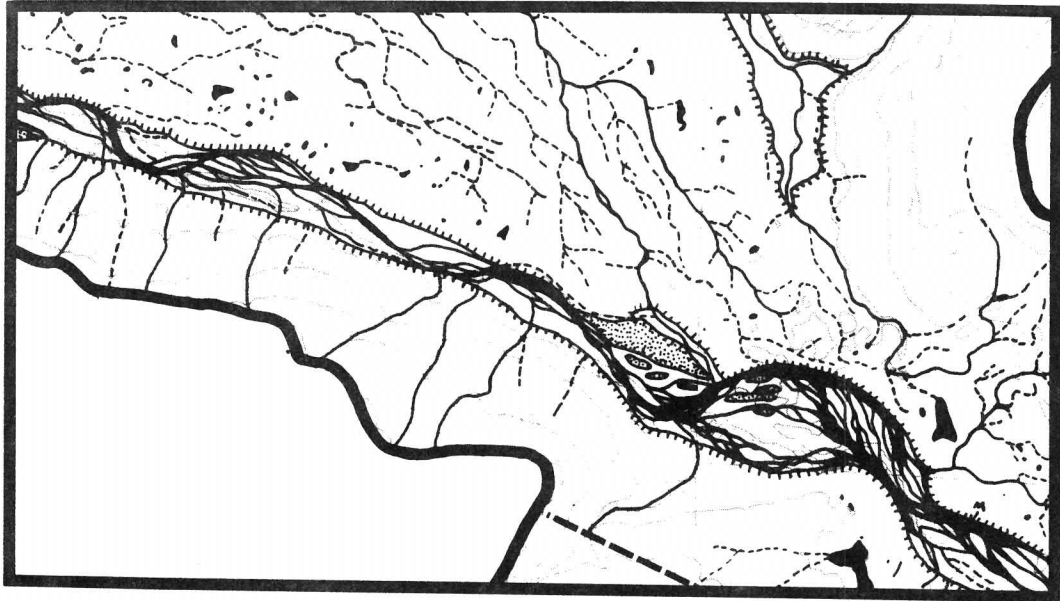
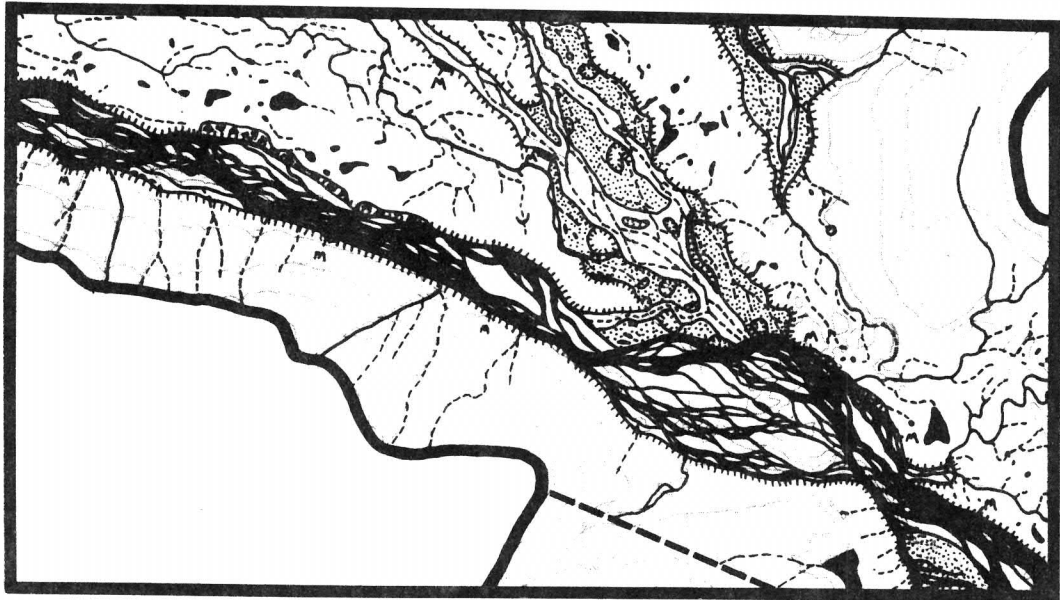
Figure 9. Location of the river bifurcation point west of Elk Rock. (Top) On the 06 February 1982 map a small off-shoot stream from the main stem of the river is flowing towards Bear Creek. A similar relationship existed on the 11 and 16 December 1981 map. (Bottom) The 05 March 1982 map illustrates the physical features that were produced by the 20 February 1982 flood surge. Note the numerous terraces located in the new floodplain. The river has since returned to its former channel. There is no longer any direct discharge into the Bear Creek system from this point, probably because of a rise in the floodplain levee.

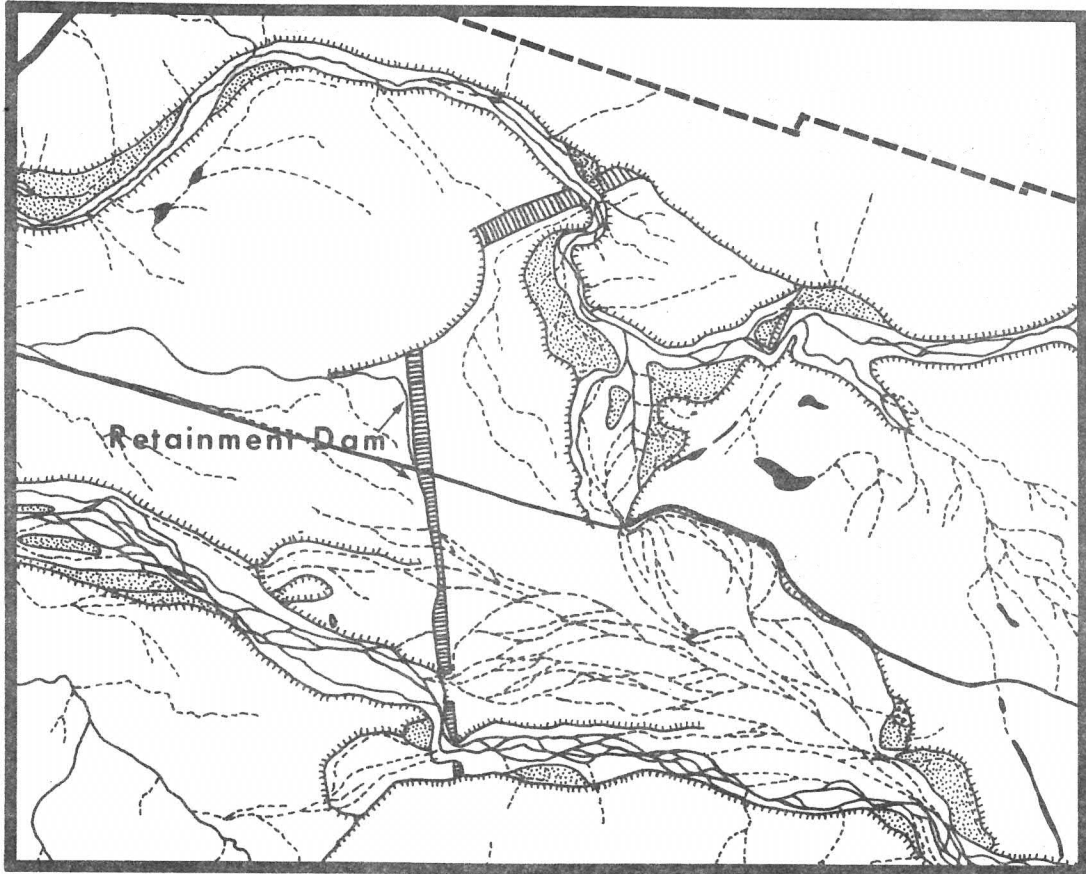
Figure 10. Physical appearance of the retention dam area on 13 October 1982.

The last of the interpretative maps, dated 13 October 1982 (Fig. 10), indicates how the main river channels have changed during the spring and summer months. At the southern end of the south dam structure the river is in the process of cutting a new channel and creating a shallow gradient alluvial fan. During high runoff periods, part of the main stem of the North Fork Toutle River now flows into Deer Creek. This river course change can be expected to continue during the coming year. As a result of a steepened river slope gradient caused by rapid down cutting through dam structures, a confining floodplain with steep embankments has been developing in both the north and south sediment storage areas. The areal extent of terraces has also increased during the summer low flow discharge period. This would suggest that the river, during the summer of 1982, was experiencing a period of degradation. This stands in direct contrast to the aggradation processes that dominated the area previously. A comparison of the sediment storage area immediately behind the south dam reveals that from October 1981 to October 1982 the width of the floodplain has increased from approximately 275 m (900 ft) to 800 m (2,640 ft); a nearly three-fold change in the actual channel width.

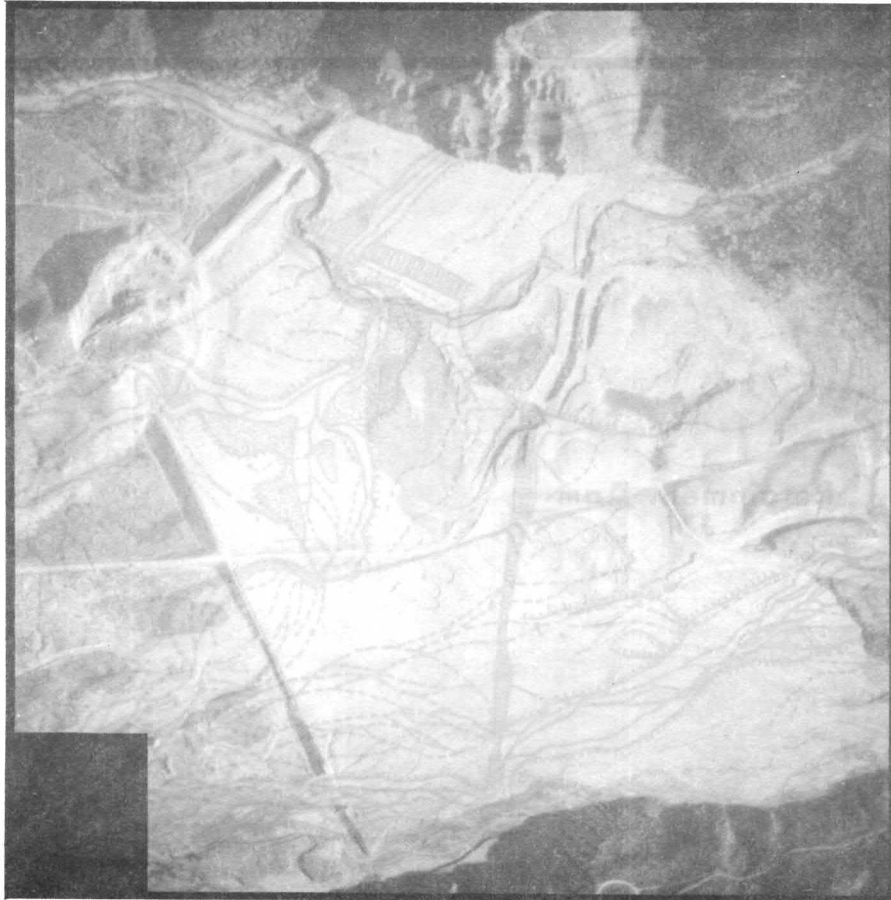
Figure 11. Aerial view of the sediment retention dam area on 13 October 1982. Compare this photograph with the interpreted map presented in Figure 10 (Oregon Army National Guard).

An aerial view of the retention dam site on 13 October 1982 is provided in Figure 11. The bright gray area indicates the spatial distribution of the sediment that had been previously deposited behind the dam structures. The darker tones within the storage area indicates the presence of antecedent moisture below the surface of the active channels. If the current trends remain significantly unchanged, the river channel can be expected to continue its down-cutting progression through the stored sediments during the course of the next several years.

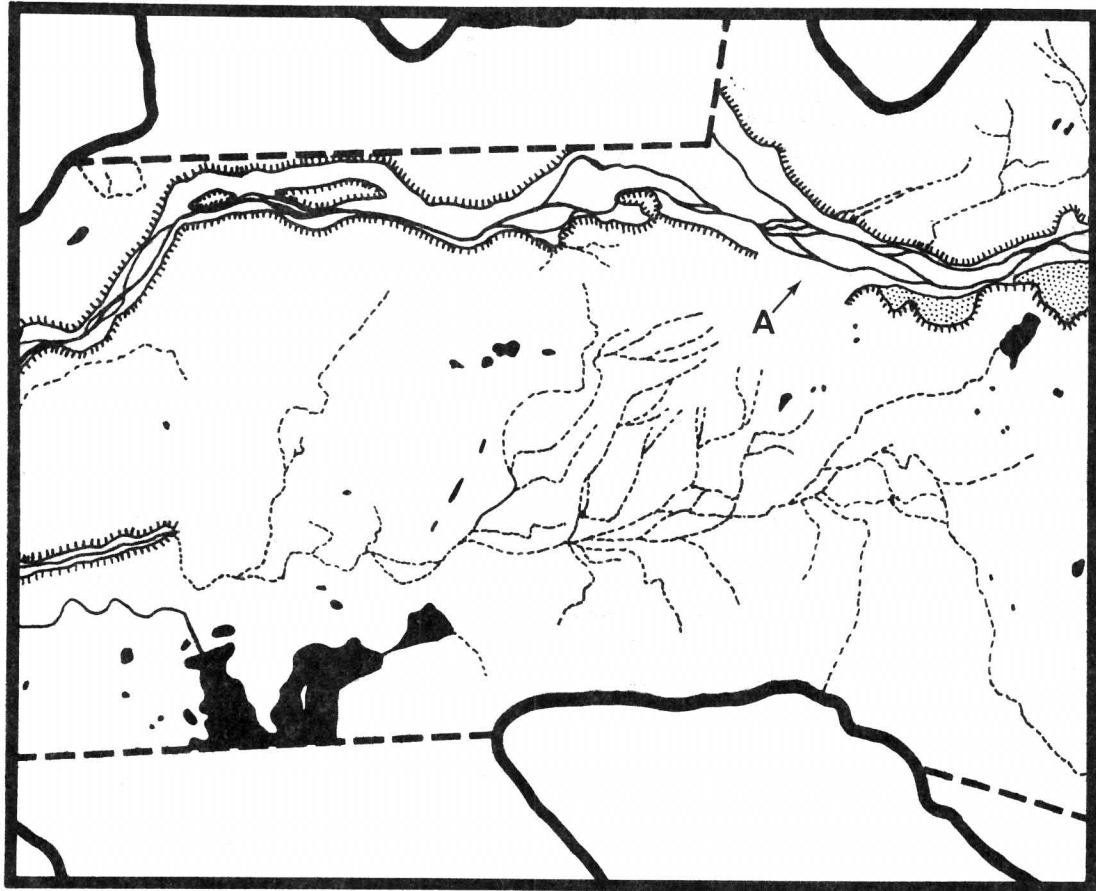
Figure 12. Physical appearance of the "braided reach" of the North Fork Toutle River on 13 October 1981. Jackson Lake is located in the lower left hand corner of the map. The natural break in the floodplain embankment is labeled "A".

The 13 October 1981 map (Fig. 12) shows the main river channel is located on the north side of the valley. Only limited braiding of the river is taking place. The interpreted features indicates periods of alternating aggradation and degradation channel processes modifying the terrain surface prior to the map date.

Degradation of the channel is limited to isolated occurrences of streambank erosion within the confines of the identified floodplain. There are only a few terraces present along the margins of the floodplain. An intermittent stream network has evolved on the generally smooth terrain surface immediately south of the main river channel. A break in the floodplain embankment is evident towards the headward source of these streams. At this hydrologically identified critical point, overflow and sediment deposition by the river have occasionally coincided with periods of peak discharge conditions. A

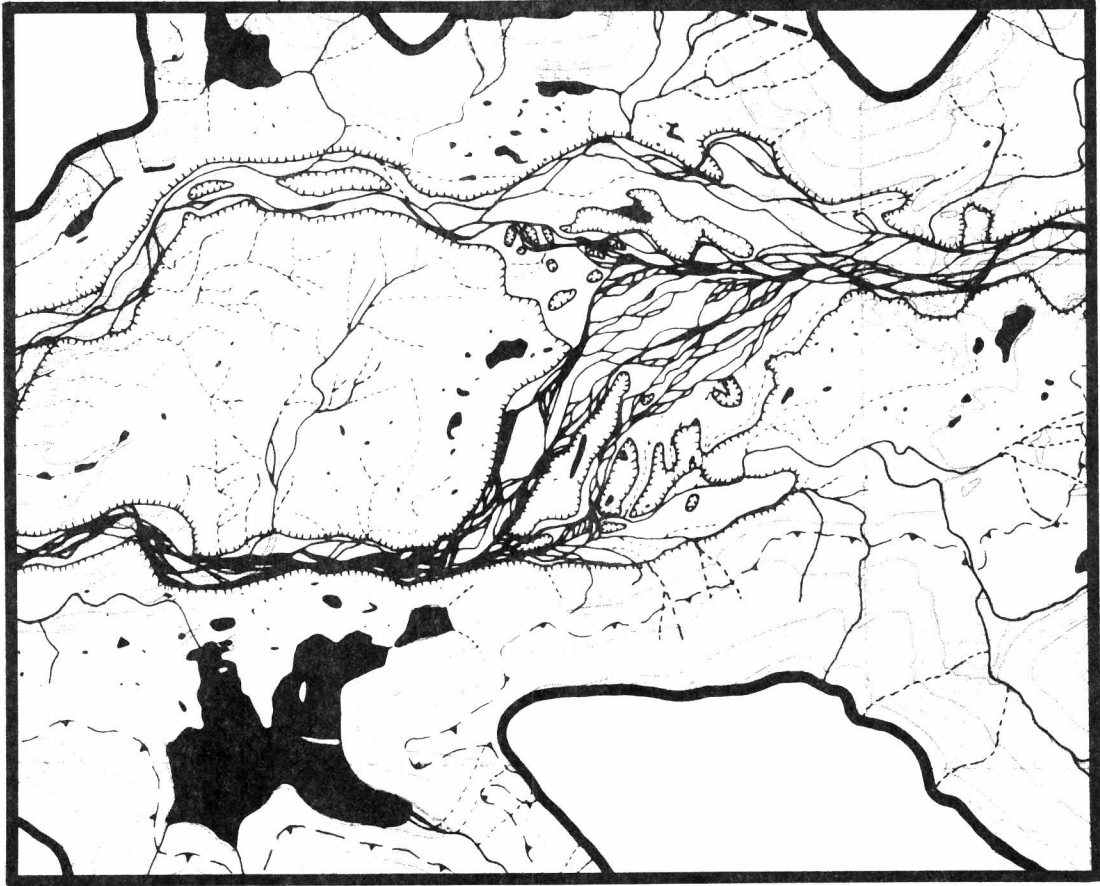
Figure 13. Physical appearance of the "braided reach" of the North Fork Toutle River on 11 and 16 December 1981.

The map dated 11 and 16 December 1891 (Fig. 13) illustrates the first full view of the hydrologic responses that took place within this selected river reach following the initial series of fall storm events. Several distinctive characteristics associated with a braided river network are clearly evident. The aggradation of sediment, transported into the area from upriver erosional sources, is the predominant hydrologic process. As a result of sediment and bedload deposition, numerous anastomosing channels are diverging and converging throughout this significantly modified reach of the river valley. The maximum width of braiding extends 480 m (1,575 ft) across a new floodplain zone that is conspicuous in its lack of confining lateral embankments and terrace developments. At the upper end of the mudflow deposit, the river network has generally bifurcated such that the greatest volume of total river discharge is flowing first towards and then along the southern half of the river valley. At this time, the river has continued to maintain a sustained flow through the northern channel as well.

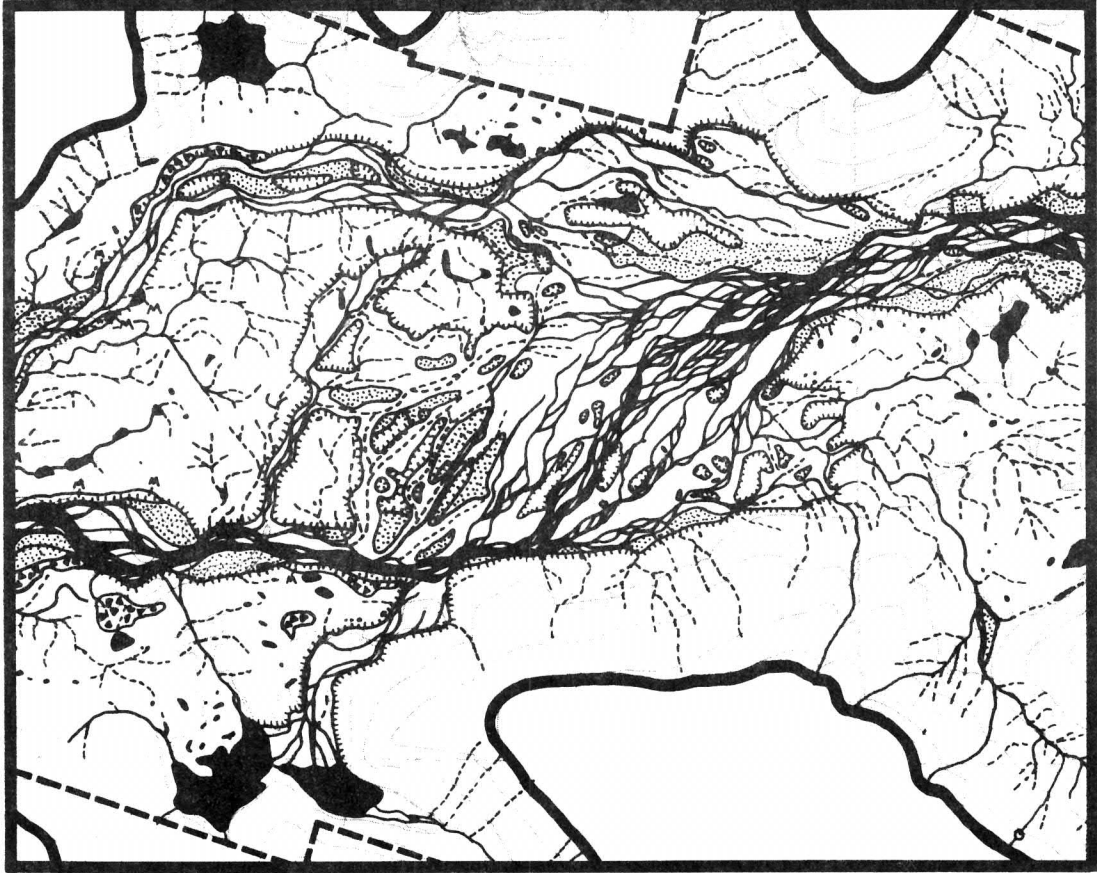
Figure 14. Physical appearance of the "braided reach" of the North Fork Toutle River on 05 March 1982.

The 05 March 1982 map (Fig. 14) further amplifies the dramatic hydro-morphological changes that have been taking place within this particular reach of the river. At the time of imagery acquisition, the river was experiencing a period of high discharge. Comparison with the two previous maps reveals a significant number of modifications to the land surface configuration in direct response to a variety of fluvial and associated mass wasting processes; especially from upriver erosional sources. Although the main channel continues to be dominated by braiding, and associated aggradational processes, the river channel is also beginning to degrade through the depositional material in the upper reaches of the braided area. Several large terraces are emerging along the floodplain margins as a result of this shift in process emphasis.

The river has moved laterally westward since December, reworking new areas of previous mudflow deposits and creating new, interconnected channels. The entire river system is becoming more integrated as the contributing streams and gullies develop their channels headward. Downcutting by the river in the northeast quadrant of the braided area is resulting in the truncation of the previously westward flowing branch of the river. Direct contribution to the northern channel is now restricted to a single flow route from the main stem of the braided river.

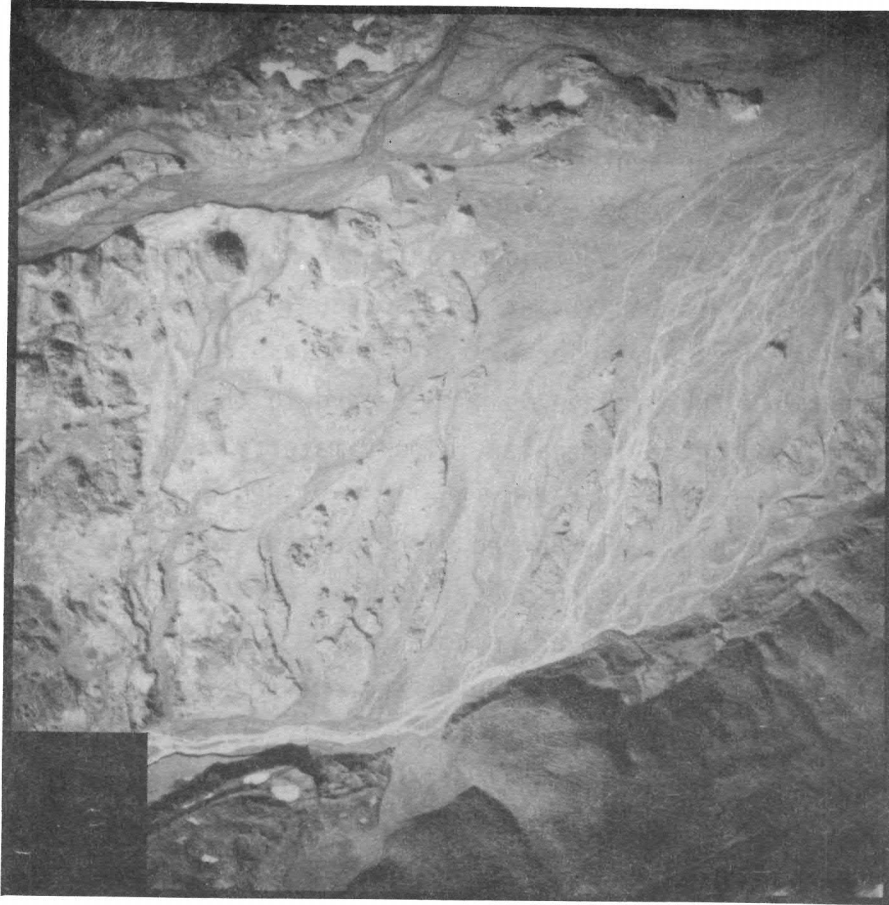
Figure 15. Aerial view of the "braided reach" of the North Fork Toutle River on 05 March 1982. Compare this photograph with the interpreted map presented in Figure 14 (Oregon Army National Guard).

Most of the various channel modifications mentioned above are effectively exemplified in Figure 15. This photo is from the series used in producing the 05 March 1982 interpretative map. The bright gray linear strands indicate the location of the flowing braided river. The gray tonal reflectance quality of the river is indicative of high concentrations of suspended sediment. Subtle textural differences in the upper right hand corner of the photo indicate the location of a large, emerging terrace and resulting truncated flow support to the north channel floodplain.

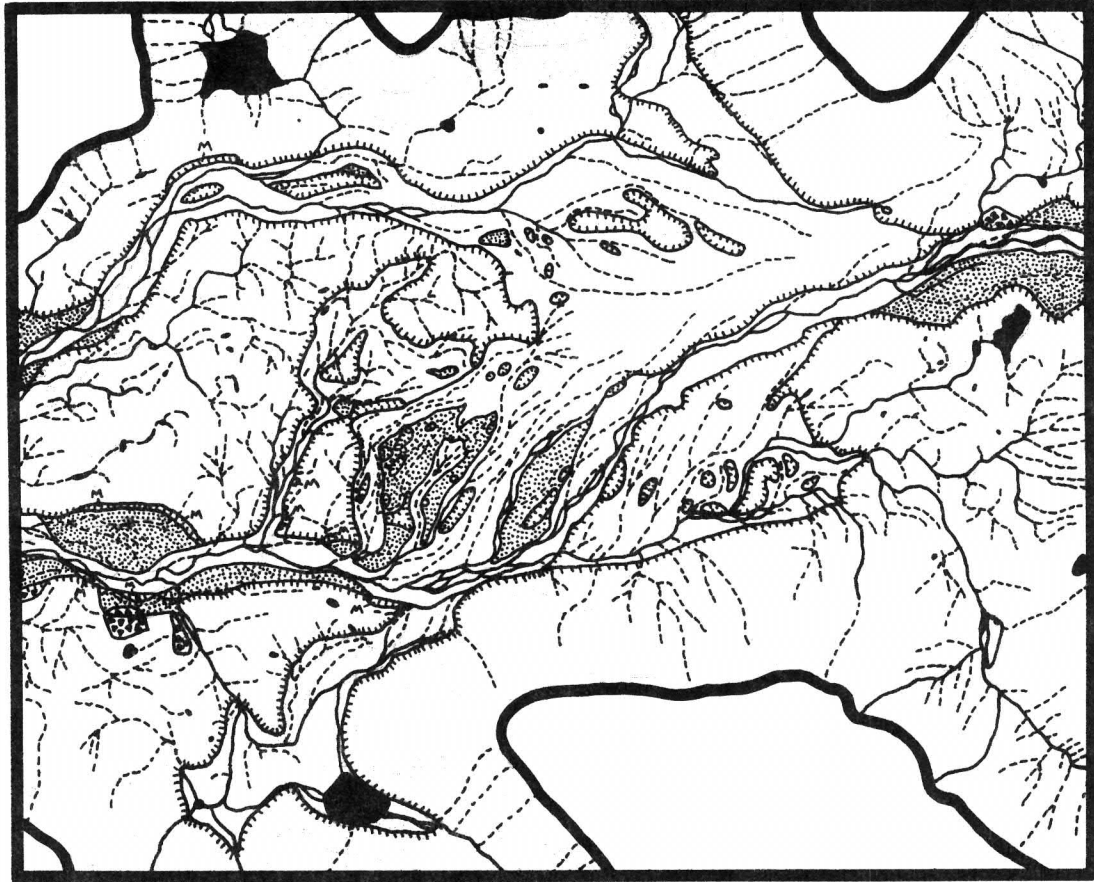
Figure 16. Physical appearance of the "braided reach" of the North Fork Toutle River on 13 October 1982.

An entrenched floodplain transecting the loosely-defined braided river area had emerged by 13 October 1982 (Fig. 16). Apparently, the period from March to October 1982 was characterized by a degradational dominance of the channel processes that was correlative with reduced discharge rates. Although river braiding continues in the restricted confines of a reduced floodplain, secondary intermittent channels are now present where previously the braided river had flowed over a wide expanse of the valley floor. There is no longer any evidence of direct contribution to the northern channel from the main river stem. Several tiers of terrace levels occupy areas both within and along the margins of the floodplain. Another notable change that has taken place is with regard to the isolated hummock islands consisting of irregular, blocky material. Most of these disjunct landform features from the 18 May 1980 eruption have either been totally or partially buried with sediment accumulations, or have experienced channel erosion processes that removed the upper most portion of the hummock mound. These changes probably occurred immediately after the completion of the previous map (i.e., during the period of March through May 1982). Entrenching of the floodplain, in contrast, probably occurred during the months of June to October 1982 which corresponds to the period of lowest discharge during the water year.

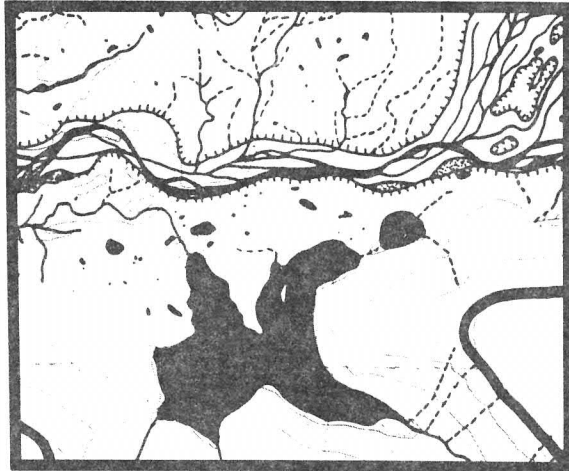
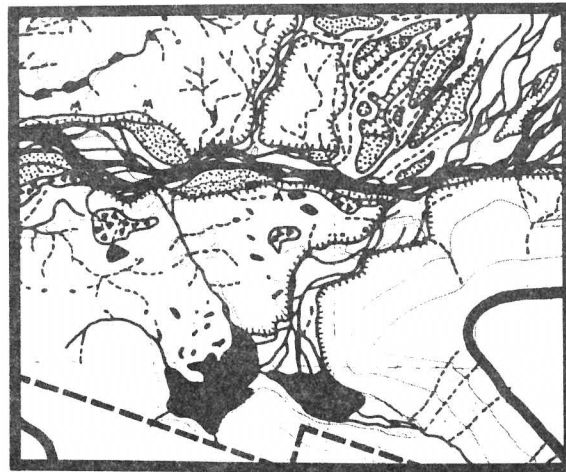
Figure 17. Jackson Lake before and after the outburst occurrence in February, 1982. (Top) The areal extent and physical appearance of the lake on 06 February 1982. (Bottom) The physical appearance of the former lake area on 05 March 1982 following inundation by the North Fork Toutle River.

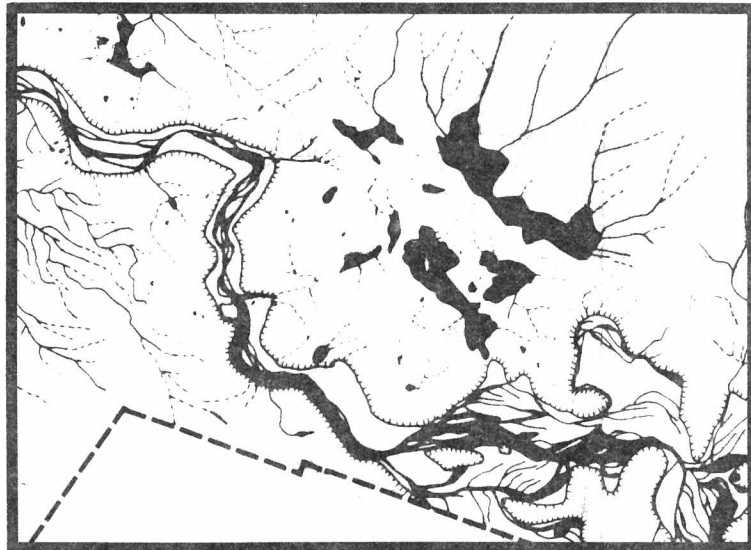
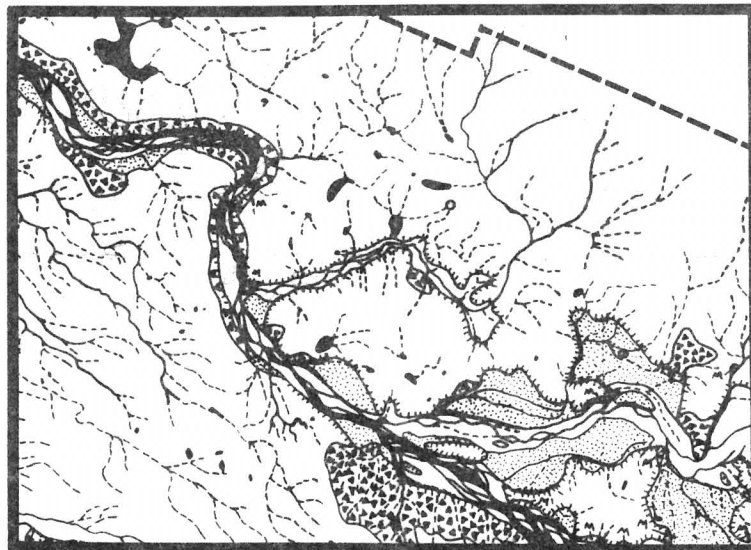
Figure 18. Evolution of an area on the flanks of Coldwater Ridge due to the occurrence of outburst ponds and lakes. (Top) Spatial distribution of depression ponds and impounded lakes on 11 and 16 December 1981. (Bottom) The same area on 05 March 1982. Note the change in the headward migration of the stream and gully network.

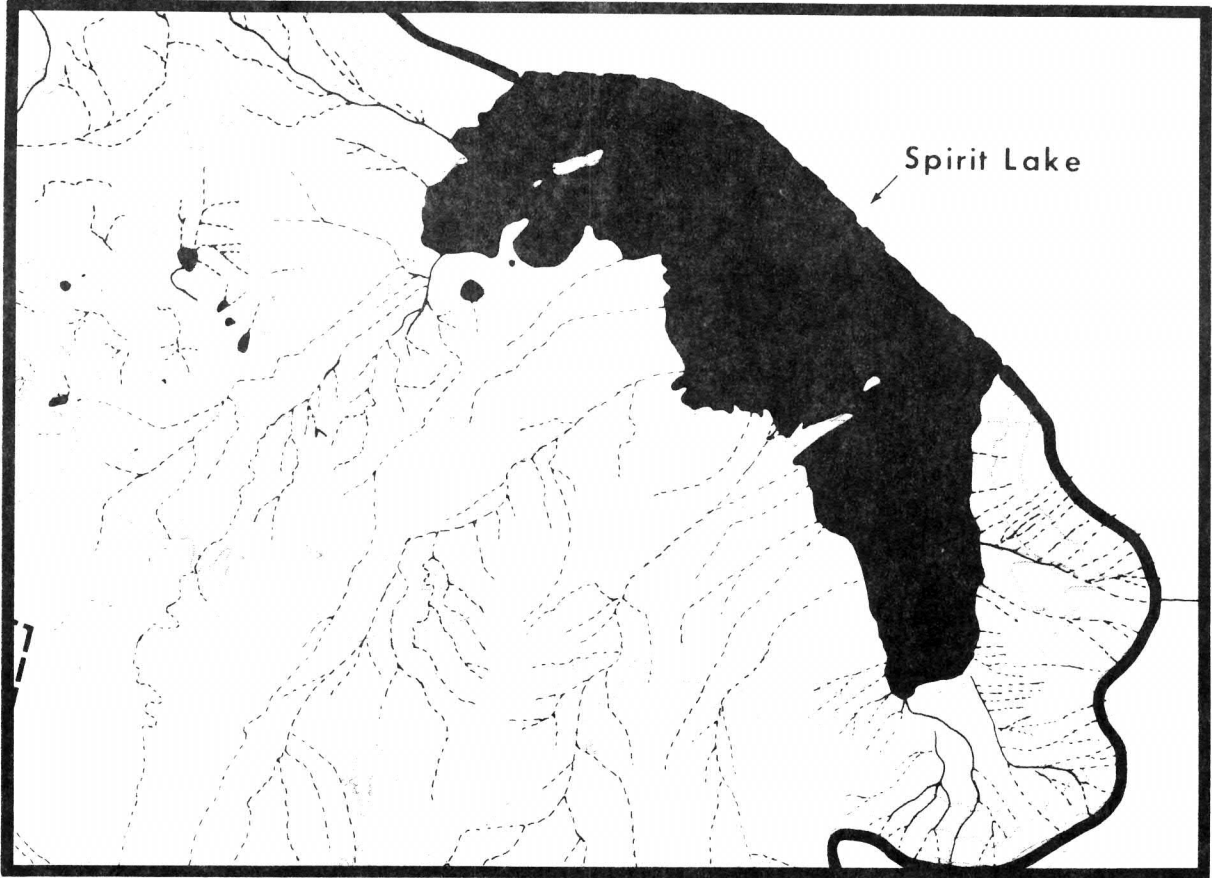
Figure 19. The location and spatial extent of the southwest portion of Spirit Lake on 11 and 16 December 1981.

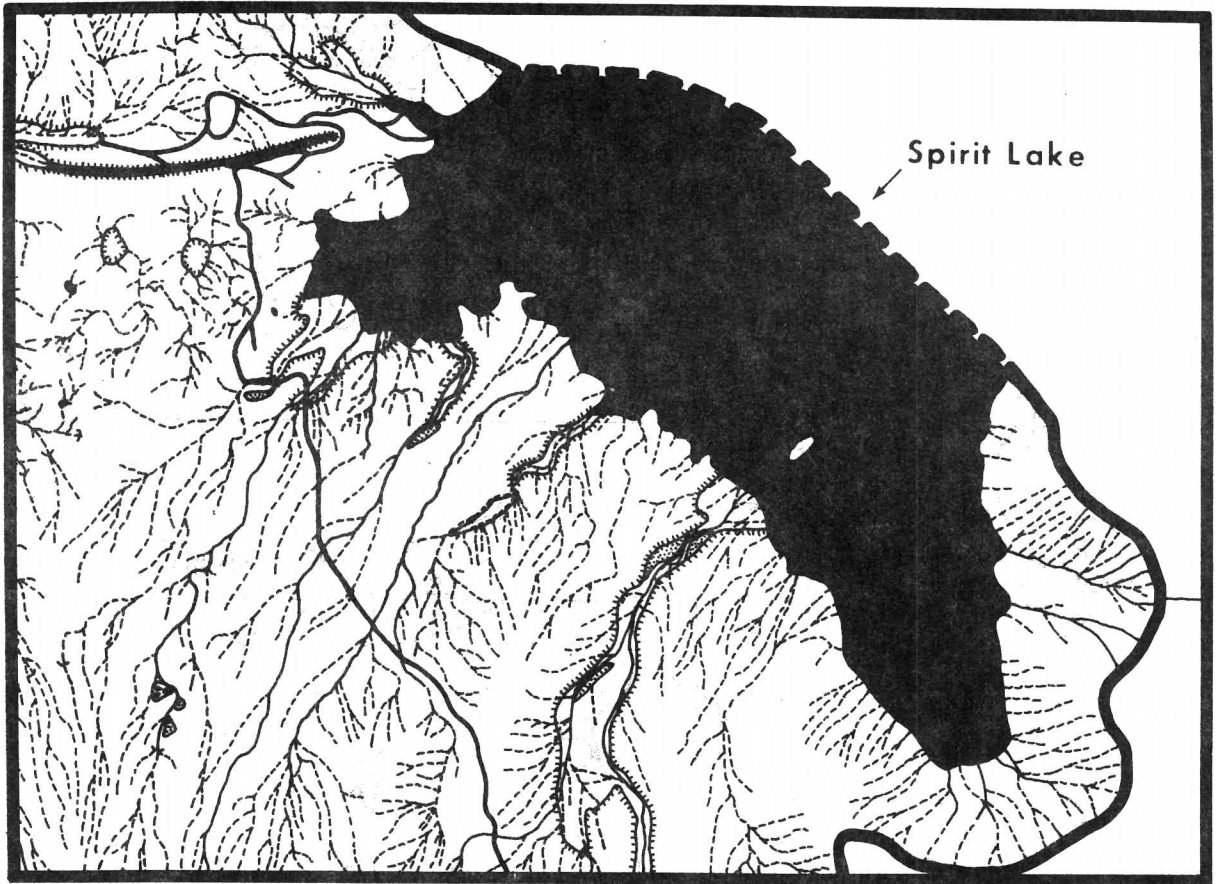
Figure 20. The location and spatial extent of the southwest portion of Spirit Lake on 13 October 1982.

deposition derived from the mountain are also present. The input of sediment, along with the occasional impacts from mudflows, contributed to the upward displacement of the lake surface and the corresponding increase in total shoreline. The major significance to this changing shoreline, of course, lies with possible consequences the encroaching waters may have on the continued stability of the debris blockage area. By the time this report was in the first draft stage, in early 1983, the shoreline of the lake had advanced to the point where the rising waters had inundated a portion of the access road delineated on the October 1982 map.
