**Evolution of a Drainage Network:  
Remote Sensing Analysis of the North Fork Toutle River,  
Mount St. Helens, Washington**

WRRRI-88

November 1983

Final Technical Completion Report  
Grant No. 14-34-0001-1452

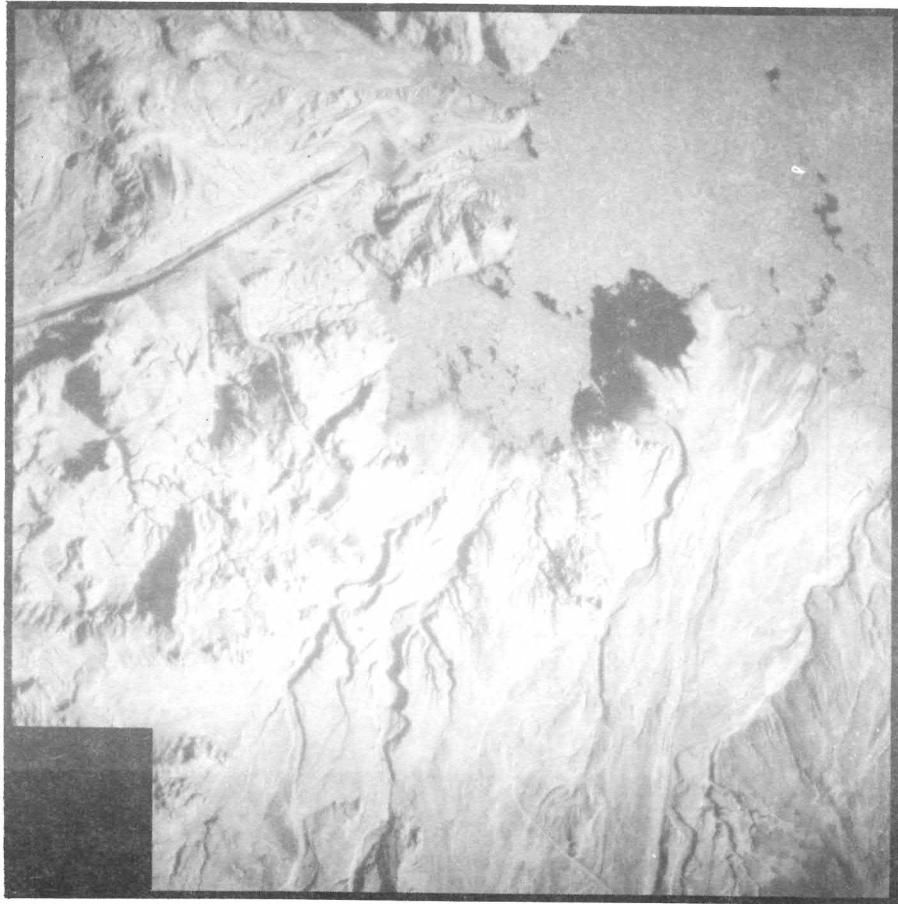
Figure 21. Aerial view of the southwest portion of Spirit Lake on 13 October 1982. Floating debris covers most of the lake surface indicating an easterly surface wind on this particular date. The access road can be seen crossing the pumice plain diagonally towards the linear-shaped drainage aqueduct constructed by the U.S. Army Corps of Engineers. Compare this photo with the interpreted map presented in Figure 20 (Oregon Army National Guard).
