USFS UMPQUA NATIONAL FOREST
NORTH UMPQUA RANGER DISTRICT
SEPTEMBER 1999

MIDDLE/LOWER STEAMBOAT CREEK WATERSHED ANALYSIS

Version 1.0
September 1999

North Umpqua Ranger District
Umpqua National Forest

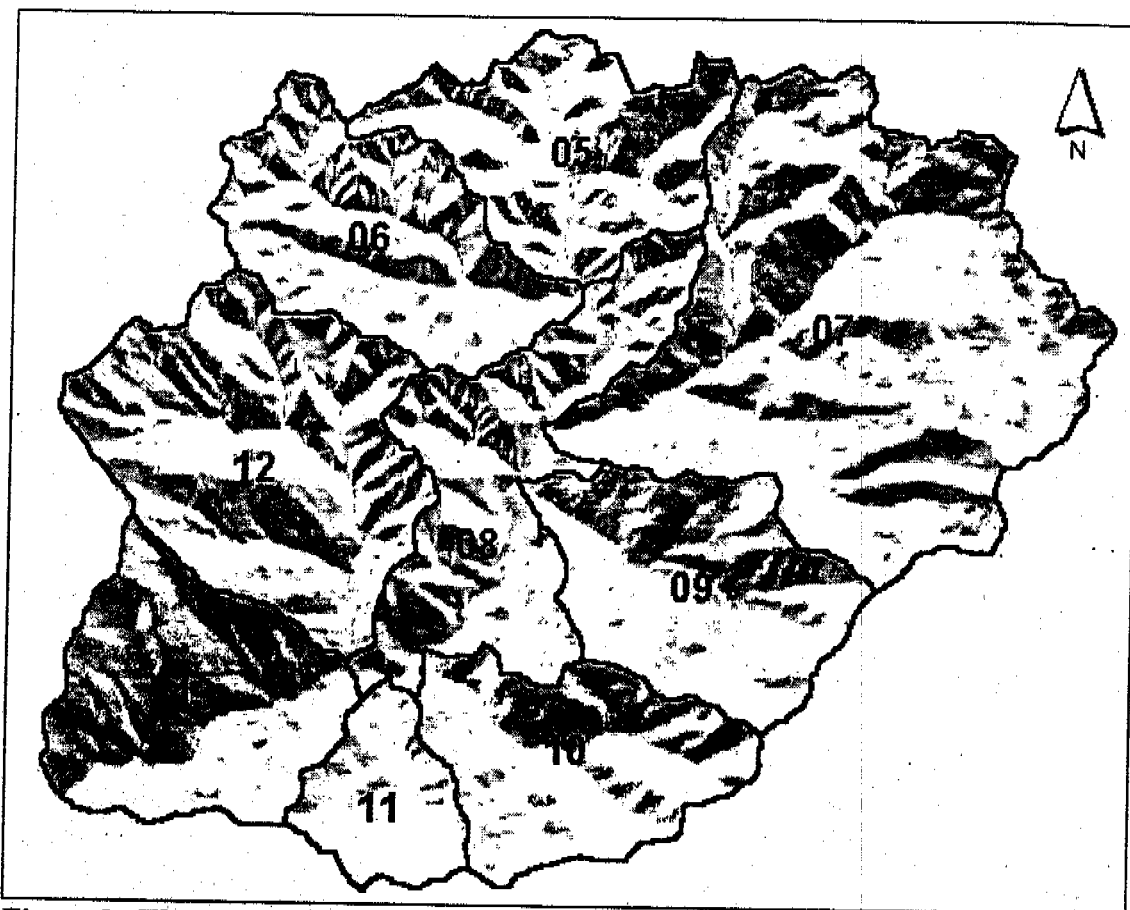
Figure 2. The nine subwatersheds of the watershed analysis area.

The analysis area was subdivided into nine subwatersheds based on logical divisions. There are 6 distinct subwatersheds, and 3 non-descript subwatersheds, or "face-drainages" (Figure 2). The nine subwatersheds are listed below:

- ◆ Upper Steamboat Face (05)
- ◆ Cedar Creek (06)
- ◆ Big Bend Creek (07)
- ◆ Middle Steamboat Face (08)
- ◆ Reynolds Creek (09)
- ◆ Singe Creek (10)
- ◆ Deep Creek (11)
- ◆ Steelhead Creek (12)
- ◆ Lower Steamboat Face (13)

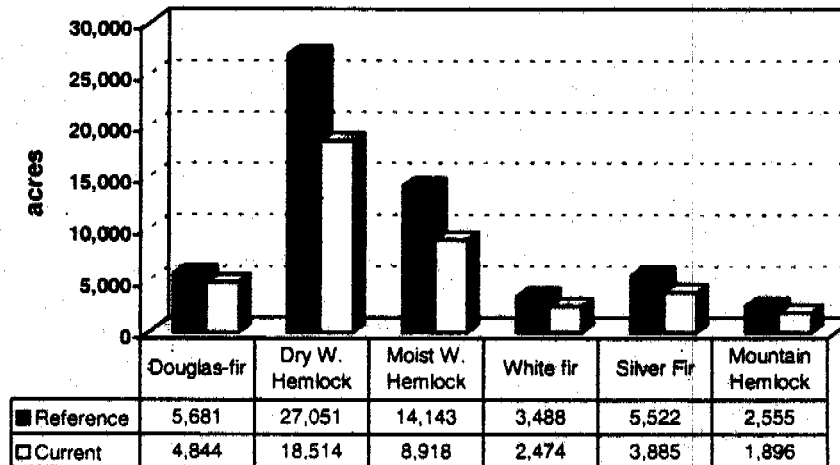
Figure 13. Reference and current acreages of late-successional forest types within the Lower Steamboat Creek watershed.

Clearcut timber harvesting and road construction have changed the spatial distribution of forest zones over the last five decades (Figure 13). The biggest change has been the reduction of the amount of late-successional forest in the western hemlock zones. Late-successional habitat within the other forest zones has decreased to a lesser degree.

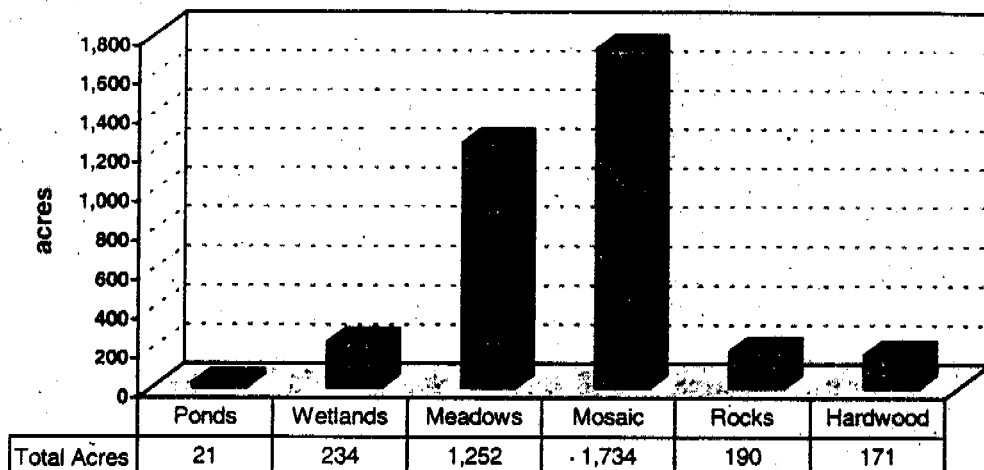
Figure 15. Acres of Unique Habitats in the Lower Steamboat Creek watershed.

There are a total of 1,880 mapped unique habitats within the watershed analysis area for a total of 3,602 acres (Figure 15). The majority of these unique habitats are meadows and mosaic areas of large trees and meadows. Wetlands and rocky outcrops are also important unique habitats.

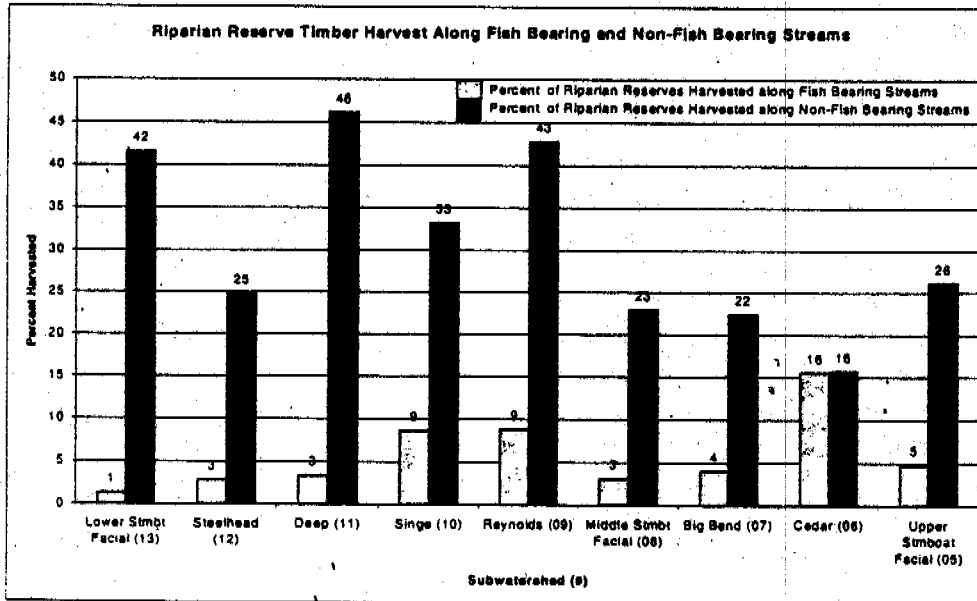
Figure 27. Percentages of riparian reserves harvested along fish and non-fish bearing streams by subwatersheds.

The riparian reserves in this analysis area cover approximately 19,493 acres, or about 27 % of the area. Of the total riparian reserve acreage, 6567 acres or 34 % has been harvested. Figure 27 summarizes the riparian reserve harvest along fish and non-fish bearing streams for each subwatershed.
