STILLAGUAMISH BASIN

Water Resource Inventory Area 05

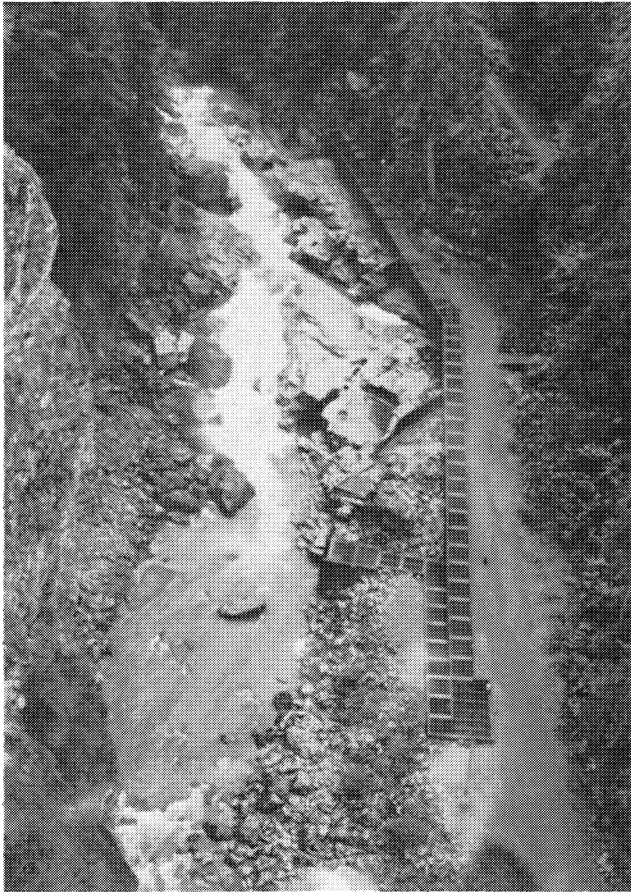
PHOTO 05-6. The Granite Falls fishway opened the opper South Fork Stillaguamish to all anadromous fish.

A major project to enhance and maintain salmon production from this reach involves containment of the large slide upriver. Subsequently, a successful gravel cleaning project would be highly beneficial, reopening extensive spawning areas. Coordination of flood control and gravel removal projects affecting the lower river's natural pool-riffle conditions and fisheries needs is desirable. Also, a Shorelines Management Plan concerning river-front developments should be initiated. To achieve better salmon use in the upper watershed, the Granite Falls fishway should be improved.

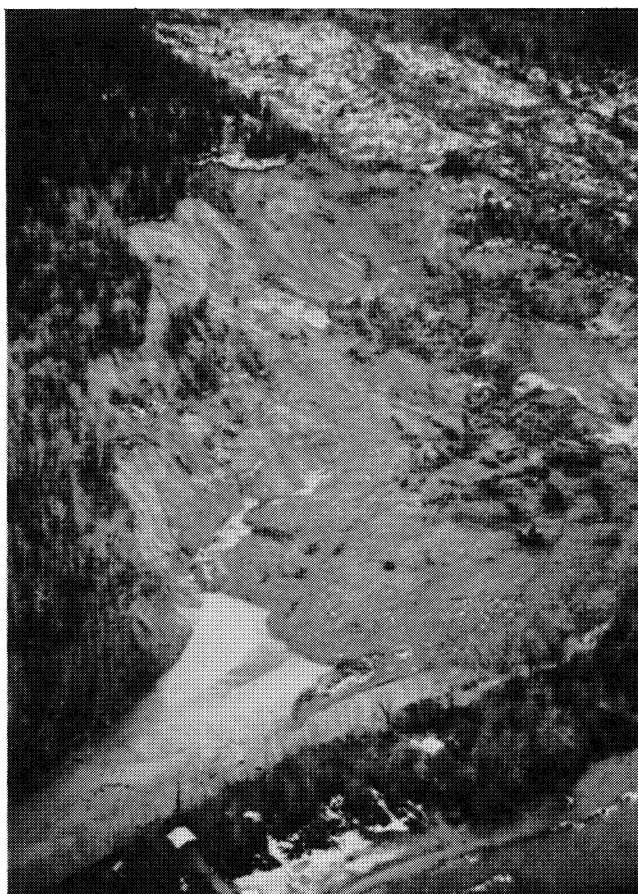
PHOTO 05-9. The North Fork Stillaguamish slide near Hazel in January 1967. This slide area causes continuing siltation problems to the river below.

Water quality — Excessive siltation caused by mud and clay slides on the North Fork near the community of Hazel and on the South Fork above the settlement of Robe contribute to poor water quality. Conditions in the downstream environment created by these slides include excessive discoloration of the water, heavy silt deposits which cause over-compaction of the streambed gravel normally suitable for spawning, and smothering of aquatic vegetation and food organisms. This heavy siltation also adversely affects sport fishing downstream. Elimination of these slides could double the total natural fish production of this river system.

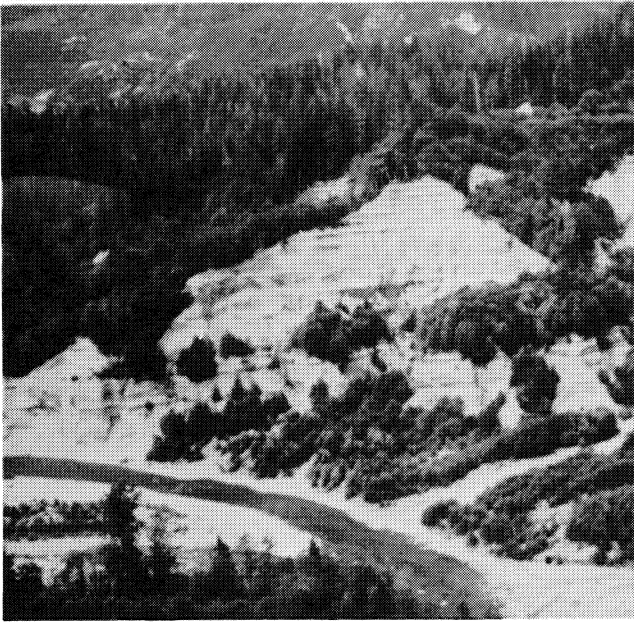
PHOTO 05-10. A major slide area impacts the lower South Fork Stillaguamish River.

The major limitation on salmon production in the lower South Fork is streambed siltation resulting from a large earth slide in the upper watershed. Many gravel riffles have been rendered unsuitable for successful spawning or egg incubation. This condition also affects the aquatic vegetation and insect production. In the canyon, a steep gradient with cascades plus fluctuations inhibits adult migration, and creates attraction problems at the fish ladder.

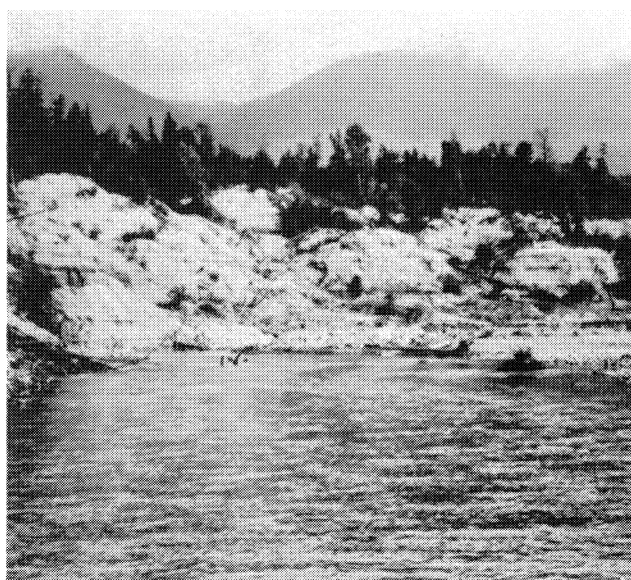
PHOTO 05-16. Slide area on North Fork near Hazel.

The principal factor limiting salmon production within this section is sedimentation resulting from a major mud and clay slide on the river's right bank, at approximately mile 20.4. Below that point, heavy silt deposits cover most of the gravel riffles, making them unsuitable for successful spawning and egg incubation. This condition also inhibits natural cycles of aquatic insect growth, reducing food production, and consequently lowering the rearing capacity of the stream below. Gravel removal operations also impose serious stream habitat alterations.

A major project to benefit salmon production habitat within the North Fork Stillaguamish would be containment of the slide at R.M. 20.4. Should this be undertaken, extensive gravel cleaning operations in the river below would be beneficial. Curtailment of the gravel removal operations and maintenance of natural stream bank cover in this section is also imperative.

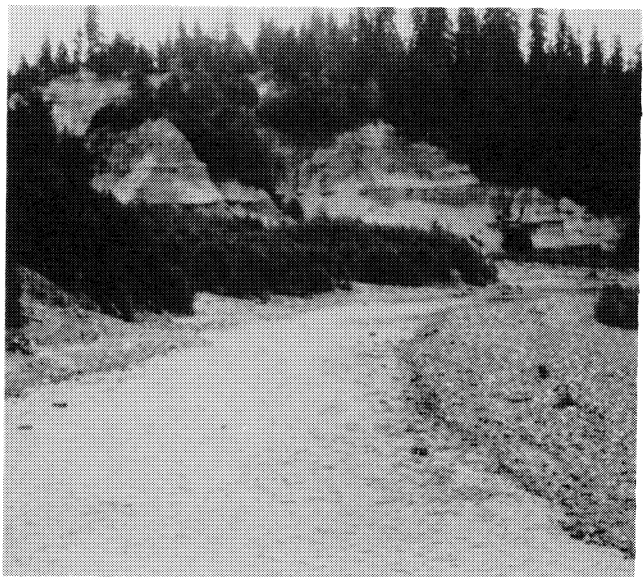
PHOTO 05-20. Slide area on South Fork near Verlot.

The major limiting factor in the South Fork Stillaguamish system is the massive earth slide located on the right bank at approximately R.M. 48.7. This causes heavy silt loading on spawning beds during periods of heavy runoff. Also, a series of cascades and rapids in the gorge can impede migration, particularly at high water. A potential for debris buildup occurs within the canyon, posing passage problems. Logging and roadbuilding activities, and the use of herbicides and insecticides in the forests offer potential hazards.
